## RMU with eco-efficient gas mixture: Evaluation after three years of field experience

### ABSTRACT

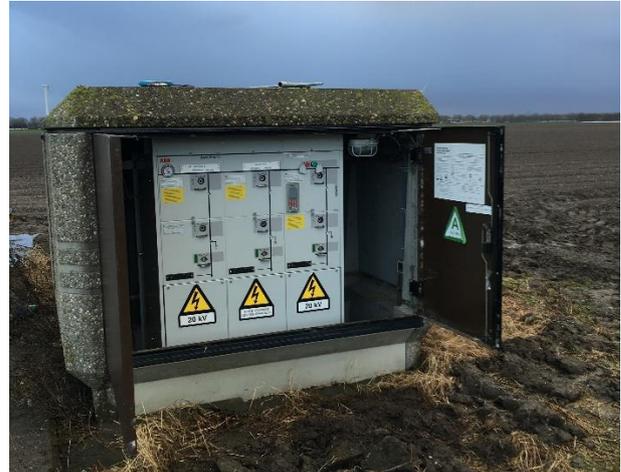
Figure 1. SafeRing AirPlus CCV switchgear installed at CSS 3 in Zeewolde, Netherlands.

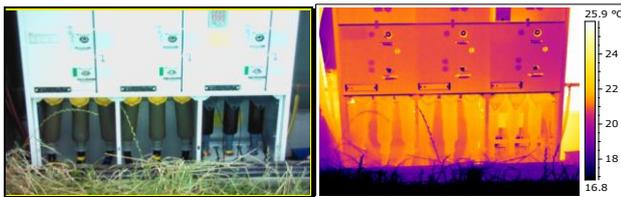
An example of an IR image showing temperature distribution in the cable compartment of an RMU at CSS 4. The load at this location during this visit was greater than 50%. It is clear from the image that there were no signs of thermal abnormality of the cable terminations and cable compartment.

Figure 3. Example of IR image acquired during inspection of RMU on 29.09.2016.

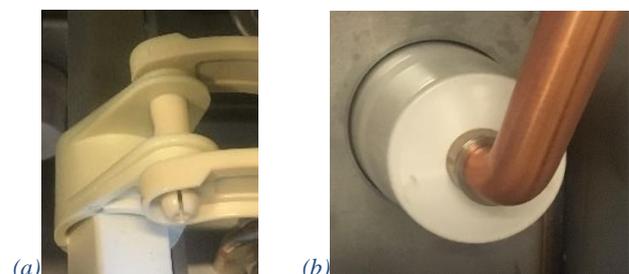
Figure 5. Pictures showing polymer parts from returned and opened field test switchgear. (a) Molded glass fiber filled PBT parts and (b) cast epoxy bushing.

When the switchgear gas compartment was opened it was clear that the material qualification procedure had worked as expected. There are no visual signs of degradation to any materials that had been exposed to the gas during the three years of the project. Example images showing the as-

new surface conditions of different metals and polymers are shown in Figures 4 and 5. From the same images it was also clear that the inside of the stainless steel gas enclosure was unaffected by the gas.
