## PRACTICAL DEMONSTRATION OF HIGH-IMPEDANCE FAULT DETECTION TECHNOLOGY IN MV DISTRIBUTION NETWORK

### ABSTRACT

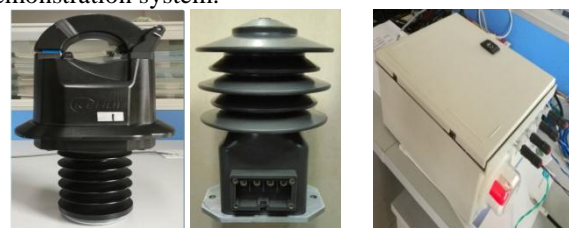
I、New type of TA      II、Centralized processing unit  
Fig.1 New suspended photoelectric current transformer

In these demonstration projects, current transformers (TA) and centralised processing units (CPUs) are installed at different nodes along the 10kV overhead line. A new type of suspended photoelectric current transformer, housed in a fault passage indicator unit, is used to acquire the current signal from the 10kV line and transmit the information to the CPU through optical fibres. The primary current signal is induced into optical signal to realize photoelectric conversion. Since the CPU does not need to operate the circuit breaker, the hardware only requires low power consumption. Therefore, the method of capacitive power supply was selected to supply power to the CPU. The 10kV voltage is transformed into low voltage AC output, which also has the additional function of voltage sensing. The CPU performs functions such as analogue measurement calculations, derivation of zero sequence components for single-phase grounding fault detection etc. It communicates with the remote master station using wireless GPRS. This configuration is illustrated in Figure 2. In the primary substation, zero sequence current and voltage transformers are installed in the 10 kV outgoing cabinet for faulty line selection. The faulty line selection device at the substation cooperate with the photoelectric current transformers and the CPUs on the line to complete the whole on-line monitoring demonstration system.

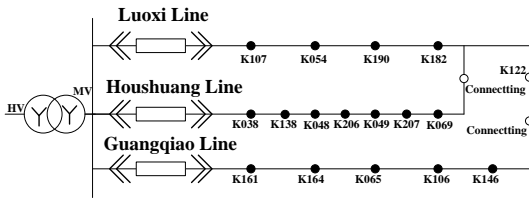
Fig.3 The ungrounded project in Quanzhou

The Quanzhou demonstration project covers 3 feeder lines. A total of 21 fault passage indicators were installed.

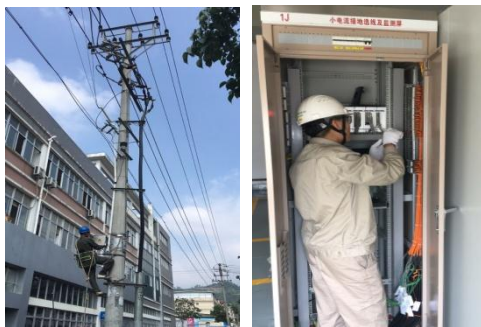
Fig.4 Site installation

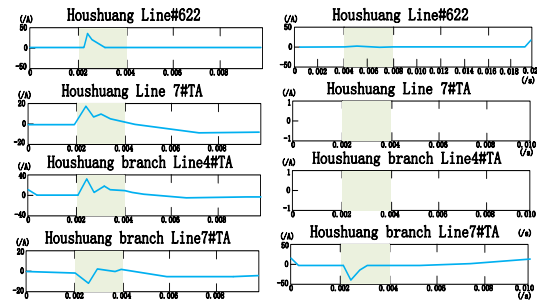
I、Through 500 $\Omega$  resistance II、Through 2000 $\Omega$  resistance

Fig.5 Recordings from the grounded project

Two sets of recorded data were shown in Fig. 5. Houshuang line (#622) was successfully identified as the faulted line by the faulty line selection device, and the location function was started. When the artificial grounding resistance is 500 $\Omega$ , the magnitude of zero sequence current is greater than 10A, which effectively realizes fault location. However, when the resistance reaches 2000 $\Omega$ , the two terminal units located in the middle tower did not record the waveforms. Therefore, the system has failed to locate the 2000 $\Omega$  fault.

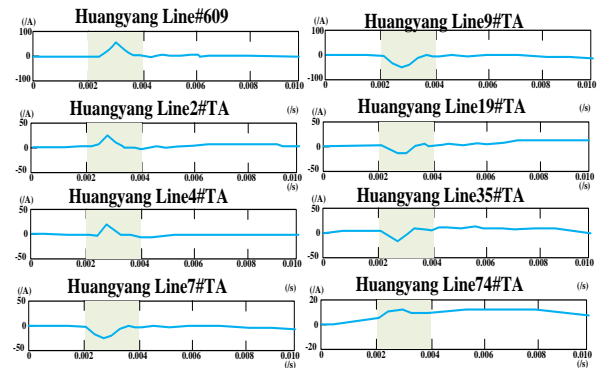
Fig.8 Artificial grounding test recordings from the Longyan project

Two sets of recorded data were shown in Figure 8. Case 1: simulated lightning strike fault conditions by arrester breakdown. Case 2: simulated the line breakage accident on the road side by single-phase grounding through cement floor. In both cases, the zero sequence current recording function can start normally, but Case 1 test failed to locate successfully. The main reason is that the abnormal signal in the system communication was not synchronized.

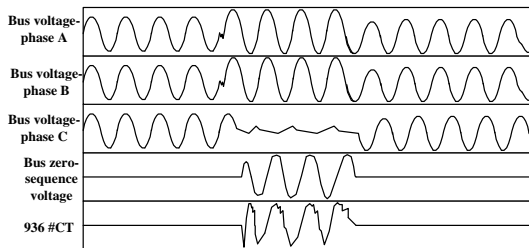
Fig.10 Recordings from the Xiamen demonstration project

Because Xiamen is located in the special economic zone, the quality of equipment, the wide-spread application of cable transmission and the maintenance of power supply are better than the other two demonstration zones, and the probability of single-phase grounding fault is less. Currently, only two sets of data were captured, as shown in Figure 10. A 90ms record of zero sequence currents at 7 amperes was obtained in Banjin II line (# 936), the faulty line selection device determined that the fault has occurred in phase C of the Banjin II line. It was found that there was a transient fault in the substation, the reason for this failure is the aging of the C phase bushing insulation in the PT cabinet.
