ASSET MANAGEMENT OF HV CABLES ON AN ELECTRICITY DISTRIBUTION NETWORK USING ON LINE CONDITION MONITORING

Graham EARP

John BURNS

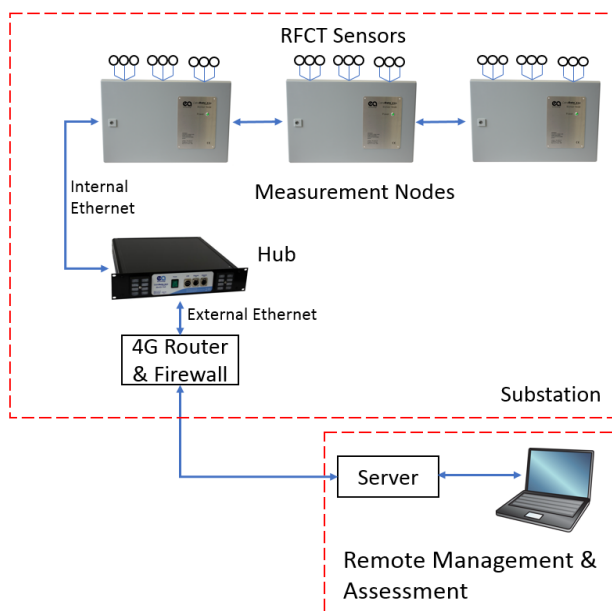
Figure 1 CDM System Block Diagram

Three separate CDM systems were installed at three separate NIE Networks substations in Northern Ireland. Each system is configured as per the block diagram shown in Figure 1.

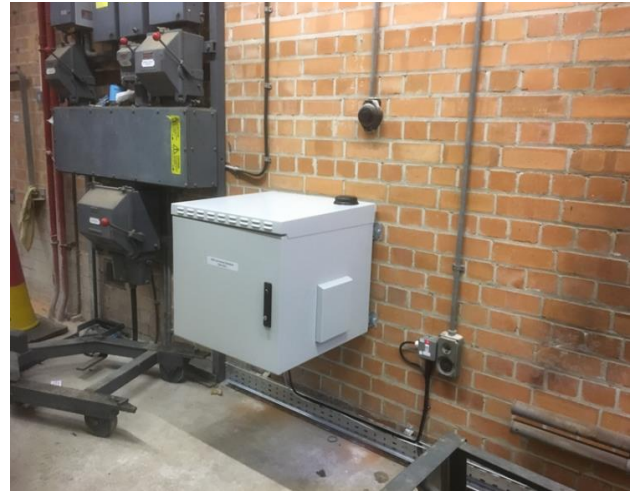
Figure 2 Hub Unit Installed Within IP54 Enclosure at Carnmoney Substation

The Hub is installed in an IP54 enclosure inside the substation (Figure 2) and the three Nodes connect to it using standard copper wire Ethernet cable (Figure 3). Each measurement Node has 9 inputs, each of which can monitor a single power cable by connecting it via a coax cable to an RFCT sensor clipped around the cable earth termination (Figure 4). Thus, each of the installed CDM systems in this configuration can monitor up to 27 individual power cables. The Node boxes are mounted physically close to the cables that they are monitoring within the substation, but the Hub can be some distance away. Data collected by each of the nodes is passed to the Hub where it is processed and stored. Each Hub is equipped with a 4G modem to provide a 24/7 continuous monitoring service and allow remote interrogation/investigation using a suite of built-in analysis tools.

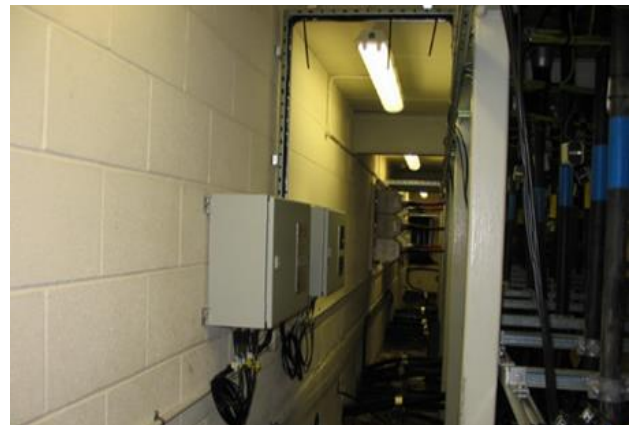
Figure 3 Node Units Installed at Belfast Central Main Substation

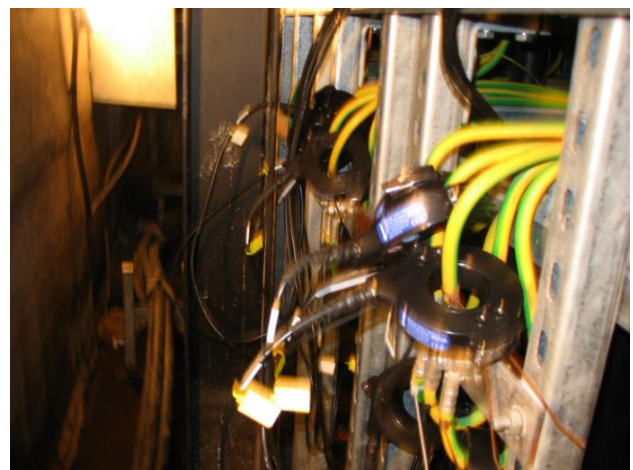
Figure 4 RFCTs Installed Around Cable Earth Straps at Skegoneill Substation

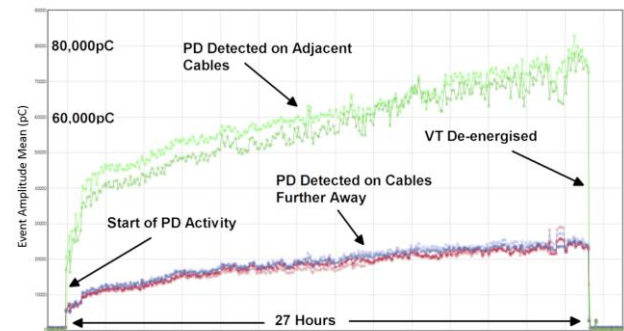
Figure 9 Detection of PD on Voltage Transformer (VT)

Figure 9 shows an example where the CDM has detected a new PD source starting to discharge fairly abruptly and continuing to increase at a rapid rate over a short period of time to relatively high levels. Alert notifications were triggered immediately the PD started. The PD behaviour was investigated remotely using the CDM. The Event Amplitude Mean trend data showed that the PD was affecting many of the cables in the substation to differing degrees. The phase plot and waveforms were not characteristic of cable PD and, for this reason, it was thought likely that the PD source originated in the HV switchgear rather than on one of the actual cables.

An engineer arranged to visit the substation in order to perform PD measurements on the HV electrical panels using a hand-held UltraTEV Plus instrument. High levels of Transient Earth Voltage (TEV) were discovered around the panel housing the 33kV Voltage Transformer (VT) which was located physically adjacent to the highest reading CDM monitored cables. On closer inspection it was observed that the VT could be heard audibly discharging. Arrangements were made to promptly remove the VT from service and replace it with another one. The plot in Figure 9 shows that the PD stopped as soon as the VT was de-energised and did not return after the replacement was fitted. This intervention prevented the VT failing completely, together with any collateral damage that may have occurred had it failed catastrophically. The example also shows that, in certain circumstances and with the appropriate analysis, the CDM can detect other PD sources in addition to those directly on the cables it is monitoring. The opportunity
